Debris flow disaster in Shizuoka, Japan on 3rd July

Qiang Ma, Shuai Wu, Xiaolei Zhang, Philippe Gourbesville

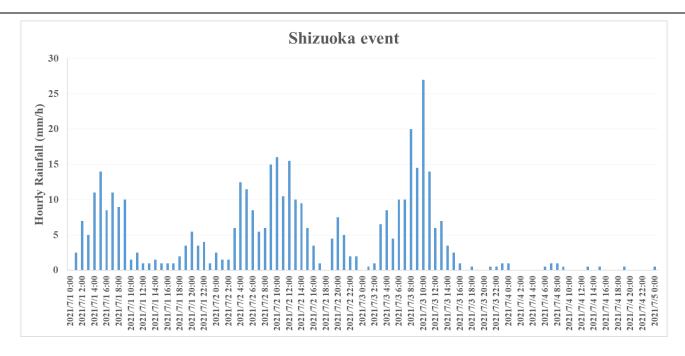
According to the observation of Japan Meteorological Agency, the local continuous rainfall began on July 1st and increased on the 3rd of July. Until 12:00am on the 3rd of July, the local 48h rainfall reached 313mm, which is much more than the monthly average rainfall of July in Shizuoka. Until 17:00pm on the 3rd of July, the 72h rainfall in Atami city, Shizuoka county was 409.5mm, almost 1.7 times higher and monthly average rainfall of July in this region.

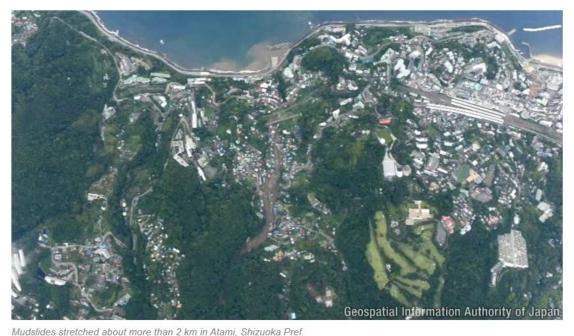
Due to continuous rainfall, a large-scale debris flow occurred in Atami city, on the morning of the July 3rd, and destroyed many houses. Moreover, the continuous rainfall has brought great difficulty to the search and rescue work. Until 5th July, the disaster has caused 9 deaths, 130 houses have been washed away. An aerial photo shows the scale of the mudslides. The debris field was 160 meters wide and stretched about two kilometers to the coast.

muusides stretched about more than 2 km in Atanii, Shizuoka Frei.

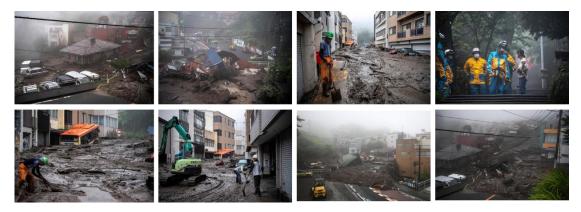
On the morning of 4th July, around 1,100 local policeman, fireman and self-defense soldier started to search the missing people. The process of search and rescue was sometimes interrupted due to the secondary disasters caused by foundation loosening. The marine security headquarters of area 3 (Yokohama) dispatched patrol boats to search the offshore area of Izu port. Divers search for people in the muddy sea caused by debris.

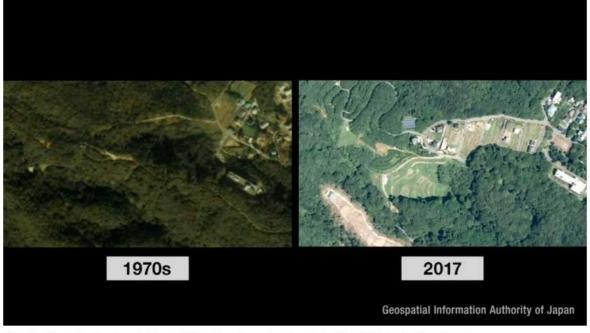
With global warming, rainstorms are increasing in Japan, resulting in more frequent landslides. For this disaster, the local officials say at least 54,000 m³ had been used to fill a valley in roughly the area where the mudslide began. That accounts for about half the amount of mud that flowed down, racing over a concrete barricade that had been built upstream and smashing into the community below.

The site where the Atami mudslides originated has been developed significantly in the last few decades.

Therefore, some of the scientists mentioned that one of the main causes of this disaster could due to the government policy which made the residential land renovation at the upstream of the catchment and lead to reduction of the capacity of water and soil conservation.
